FIRE RISK ASSESSMENT

The Regulatory Reform (Fire Safety) Order 2005

Address of premises	The Pavillion, Burton Road, Lincoln LN1 3AH		
Responsible Person (Communal Areas)	The Pavilion Management Company Limited – Managing Agent		
Signature of Assessor	<i>Liam Bee</i>	Date of Assessment	31/07/18
Date of Previous Assessment	02/08/2017	Date for review	12 months or following any change to the building, change in work processes, following any incident or reason to believe it is no longer valid.
	<p style="text-align: center;">General Comments</p> <p>The assessment is non-intrusive, no inspections are made to those parts of the building or its services which are built-in, covered up or otherwise made inaccessible in the normal course of construction, fitting out or occupation, ceiling voids, ducts or the like are not entered during the inspection, therefore no guarantees can be given that any such parts of the property are free from defects/hazards.</p> <p>The purpose of this report is to provide an assessment of the risk to life from fire in this building, and, where appropriate, to make recommendations to ensure compliance with the Regulatory Reform (Fire Safety) Order 2005.</p> <p>Th

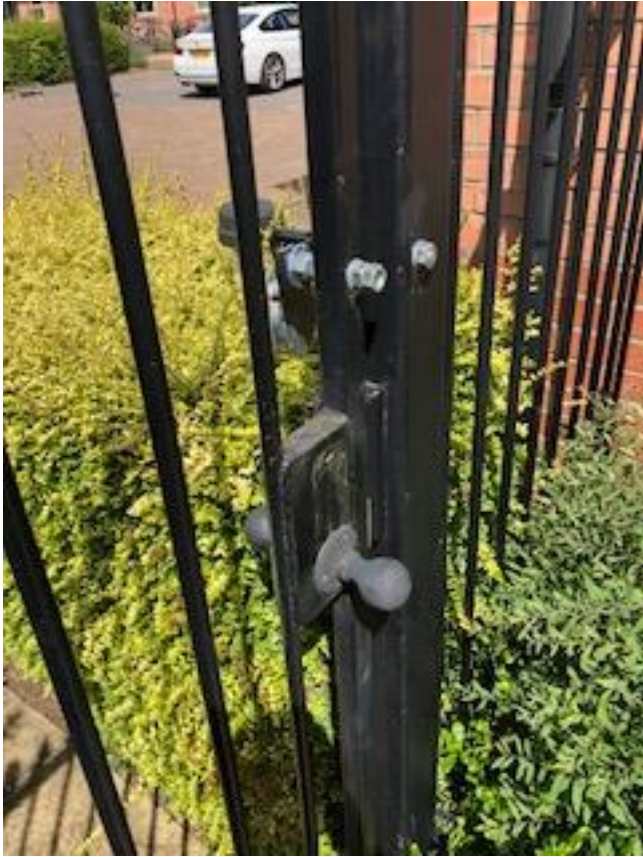
REF	
1

11	Means of Escape from Fire	Yes	No	N/A	Comments
11.1	Is the building provided with a reasonable means of escape from fire?		✓		The gate which would lead to a place of safety at the side of the building is padlocked shut See action point 2 – High Priority See Photo – Ref 1

11.7	Are fire exits immediately and easily to open e.g. without the use of a key?		✓		Not a fire exit however access from the rear of the premises out of the gardens is locked See action point 2 – High Priority

(2) 11.1 11.7	High	<p>The gate shown in photo reference one is padlocked shut from the front. This route is not suggested as an escape route however should a fire break out in the area to the front doors such as electrical cupboards, escape from the rear would be required.</p> <p>Suggest that this is replaced with a push pad from the rear and key coded entrance to the front.</p>
